Intel[®] Itanium[™] Processor

Specification Update

December 2001

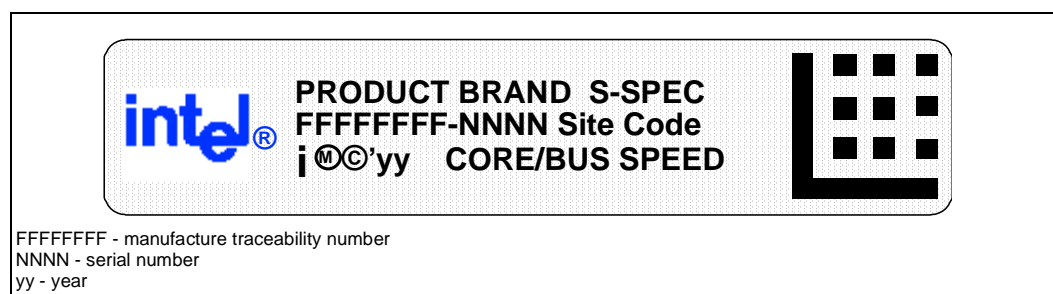
The cartridge mark for the product is a laser marked label attached to the end of the PAC418 cartridge opposite the power tab. The mark provides the following information:

- Product brand name
- Manufacture traceability (including manufacturing lot and unit identification)
- Manufacturing site
- Mask work and copyright protection for the processor and cache die
- Product identification (including processor core speed, cache size, bus speed)
- Intel company logo
- Two-dimensional product identification matrix for Intel internal use
